U. S. PUBLIC LAND SURVEY MONUMENT RECORD

**SECTION 1, T13N, R1W, TOWN OF UNION
VERNON COUNTY, WISCONSIN**

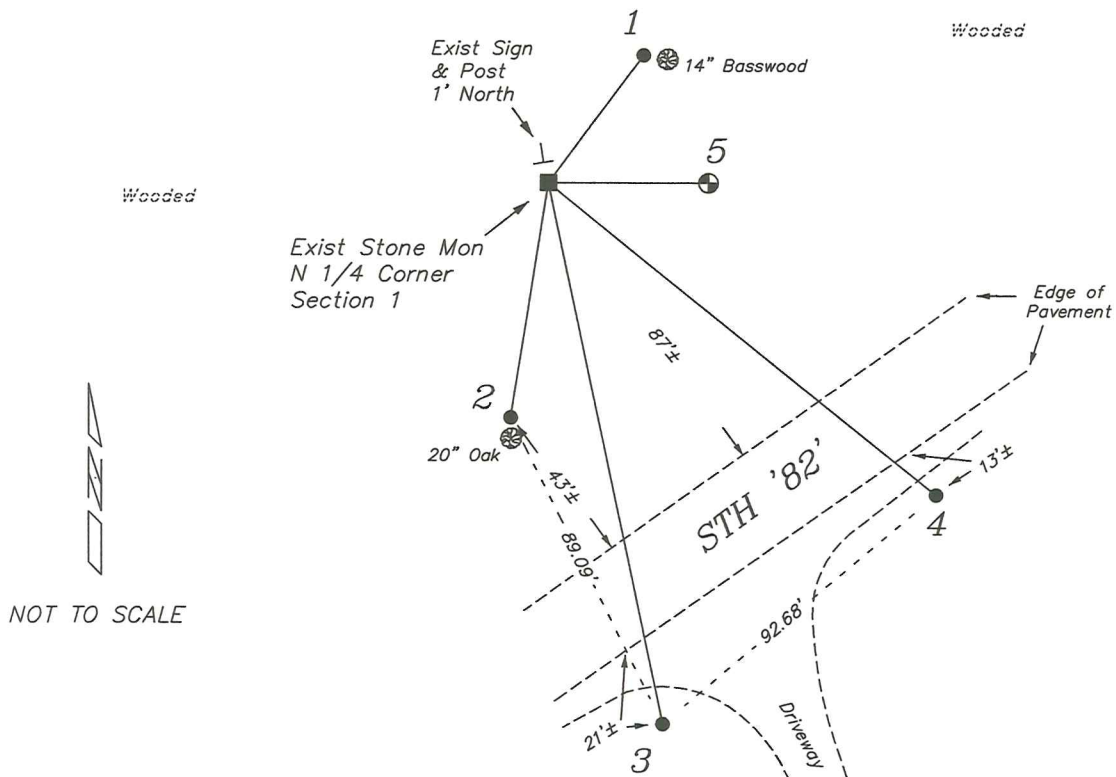
PLAN VIEW DRAWING OF REFERENCE TIES

NO	DESCRIPTION	BEARING	DISTANCE
1	Existing 3/4" Iron Rod 1' West of a 14" Basswood	N 36°40'25" E	41.52' (41.78')
2	Set 3/4" x 18" Iron Rod 1' North of a 20" Oak	S 09°06'03" W	124.03'
3	Set 3/4" x 18" Iron Rod 1' South Address Sign Post	S 11°53'15" E	288.36'
4	Set 3/4" x 18" Iron Rod In Ditch Line	S 51°00'03" E	259.32'
5	Lunde Monument S 1/4 Corner - Section 36	S 89°50'40" E	41.65'
