U. S. PUBLIC LAND SURVEY MONUMENT RECORD

**SECTION 5, T13N, R1W, TOWN OF UNION
VERNON COUNTY, WISCONSIN**

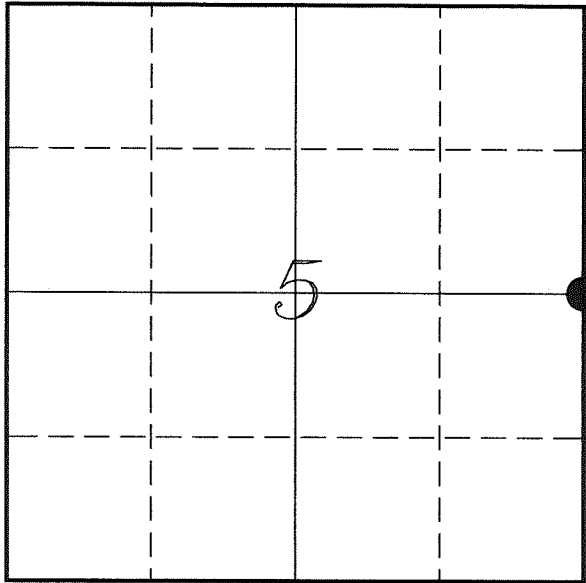
LOCATION OF LANDMARK

<i>VERNON COUNTY COORDINATE SYSTEM</i>	
<i>Northing</i>	<i>176980.664</i>
<i>Easting</i>	<i>801790.718</i>
<i>Datum</i>	<i>NAD 1983 (2011)</i>
<i>Elevation</i>	
<i>Datum</i>	
<i>TYPE OF LANDMARK:</i>	
<i>Set Lunde Monument</i>	
<i>4" Brass Capped</i>	
<i>Iron Pipe</i>	
<i>BEARINGS ARE REFERENCED TO:</i>	
<i>Vernon County Coordinates</i>	
<i>(Survey Grade)</i>

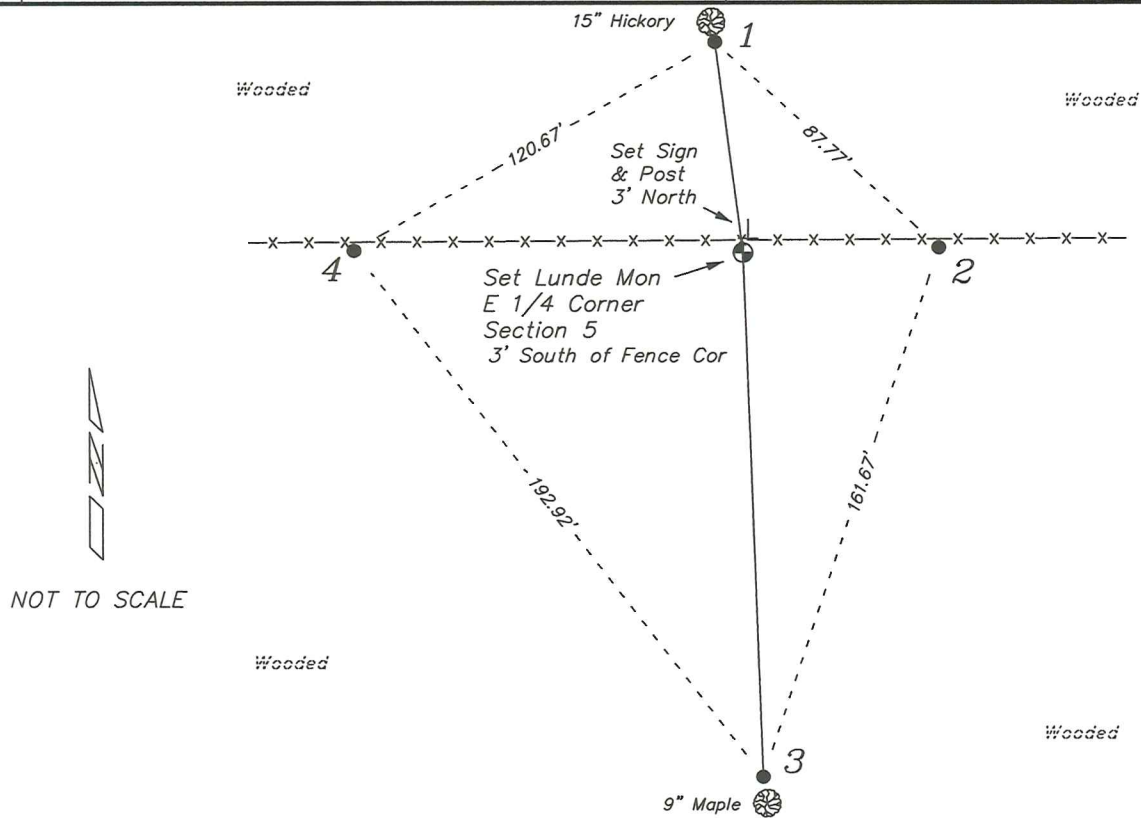
PLAN VIEW DRAWING OF REFERENCE TIES

NO	DESCRIPTION	BEARING	DISTANCE
1	Set 3/4" x 18" Iron Rod 2' South of a 15" Hickory	N 07°25'14" W	61.55'
2	Set 3/4" x 18" Iron Rod In Fence	N 88°30'11" E	56.54'
3	Set 3/4" x 18" Iron Rod In Down Fence - 9' North of a 20" Maple	S 02°05'59" E	152.06'
4	Set 3/4" x 18" Iron Rod South Side of Wood Fence Post	N 89°39'50" W	112.43'

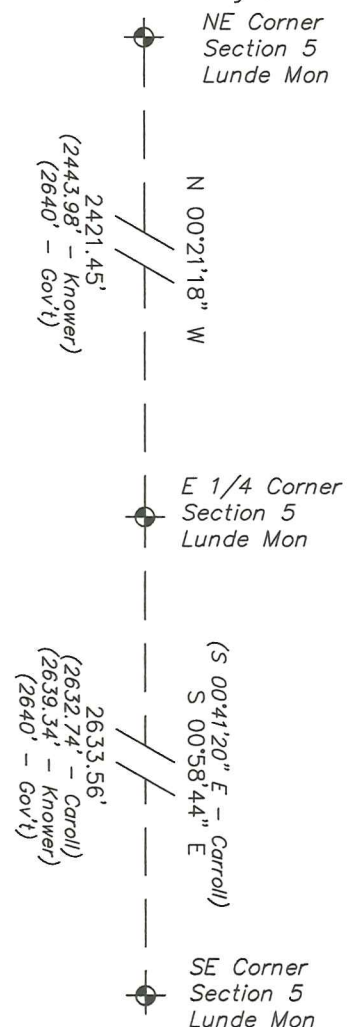
Map Showing Distance And Direction To Other Public Land Survey
Corners Used For Re-Establishing The Corner
