U. S. PUBLIC LAND SURVEY MONUMENT RECORD

**SECTION 8, T13N, R1W, TOWN OF UNION
VERNON COUNTY, WISCONSIN**

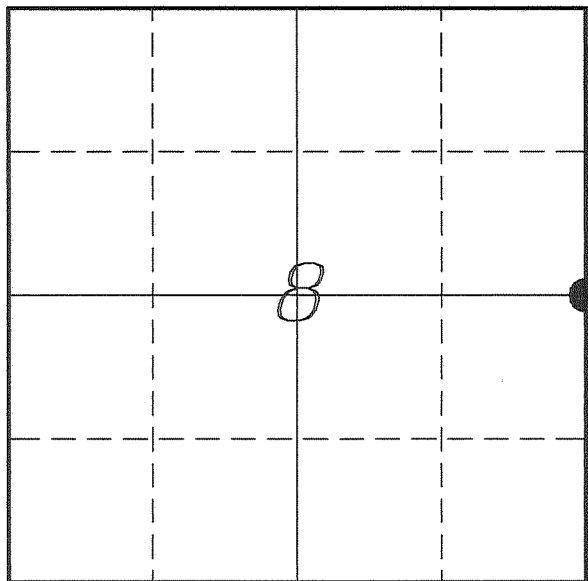
LOCATION OF LANDMARK

<i>VERNON COUNTY COORDINATE SYSTEM</i>	
<i>Northing</i>	<i>171689.325</i>
<i>Easting</i>	<i>801851.745</i>
<i>Datum</i>	<i>NAD 1983 (2011)</i>
<i>Elevation</i>	
<i>Datum</i>	
<i>TYPE OF LANDMARK:</i>	
<i>Set Lunde Monument</i>	
<i>4" Brass Capped</i>	
<i>Iron Pipe</i>	
<i>BEARINGS ARE REFERENCED TO:</i>	
<i>Vernon County Coordinates</i>	
<i>(Survey Grade)</i>

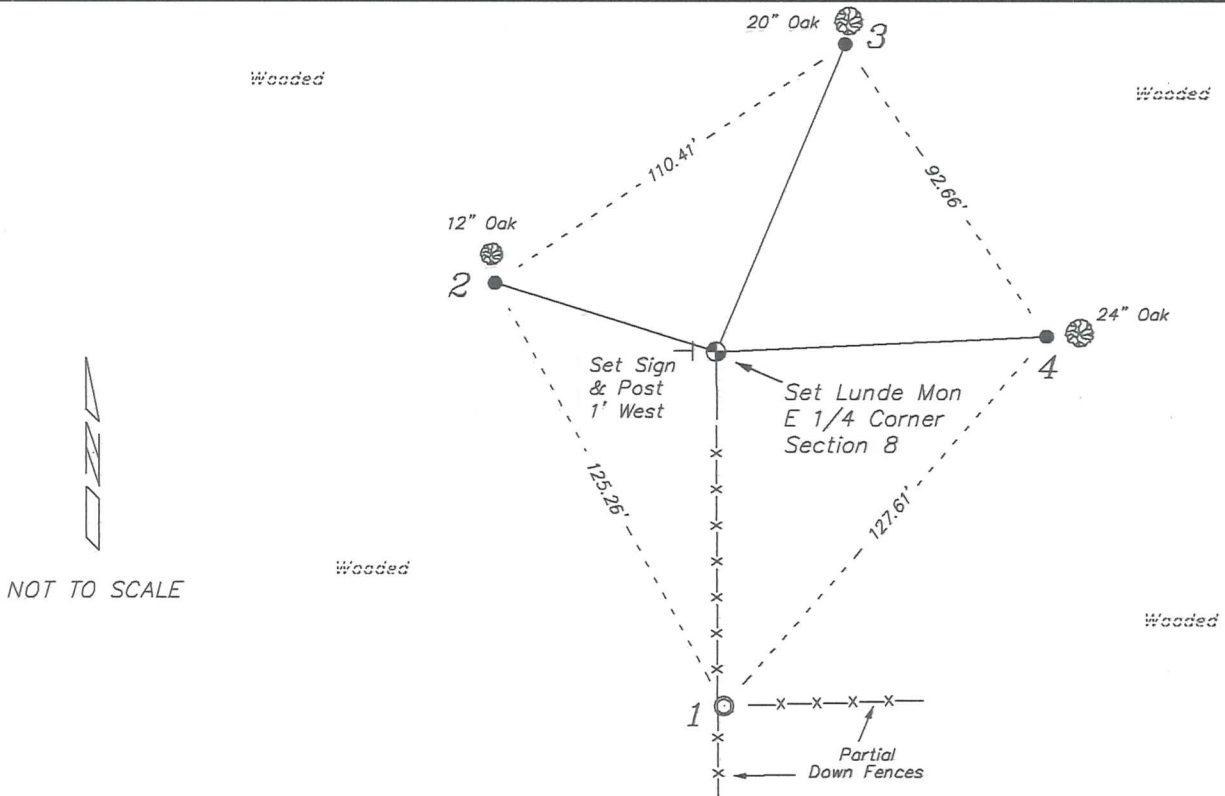
PLAN VIEW DRAWING OF REFERENCE TIES

NO	DESCRIPTION	BEARING	DISTANCE
1	Existing 1 1/2" Iron Pipe In Fence Line	S 01°20'14" E	92.19'
2	Set 3/4" x 18" Iron Rod 1' South of a 12" Oak	N 72°33'19" W	60.16'
3	Set 3/4" x 18" Iron Rod 2' South of a 20" Oak	N 22°40'38" E	87.25'
4	Set 3/4" x 18" Iron Rod 2' West of a 24" Oak	N 87°18'04" E	86.08'
