U. S. PUBLIC LAND SURVEY MONUMENT RECORD

SECTION 5, T13N, R1W, TOWN OF UNION VERNON COUNTY, WISCONSIN

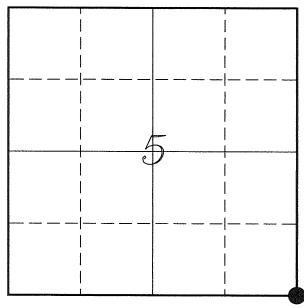
LOCATION OF LANDMARK

Found the 6" spike set and used by Carroll in several surveys. It was set at the East edge of a 24" Oak tree with old and new wire wrapped around it and used as a fence corner for a number of years.

This corner is at the top of a hill and fences are somewhat erratic but once off the hill all fences that were checked did line up with this location.

Due to the roots of the tree and the rocky terrain was not able to set a Lunde Monument but was able to replace the spike with a $1 \frac{1}{4}$ iron rod which was more stable.

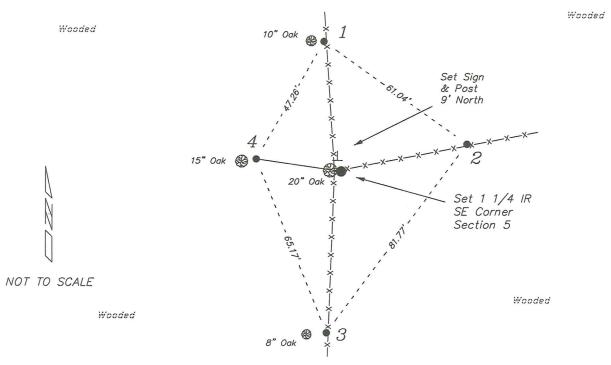
PLAN VIEW DRAWING OF REFERENCE TIES

NO	DESCRIPTION	BEARING	DISTANCE
1	Set 3/4" x 18" Iron Rod In Fence — 1' East of a 10" Oak	N 07°33'29" W	45.70'
2	Set 3/4" x 18" Iron Rod In Fence Line — At Ridge Crest	N 77°31'59" E	44.57'
3	Set 3/4" x 18" Iron Rod In Fence — 4' East of 8" Oak	S 05°07'33" W	56.40'
4	Set 3/4" x 18" Iron Rod 2' East of a 15" Oak	N 81°46'26" W	29.75'

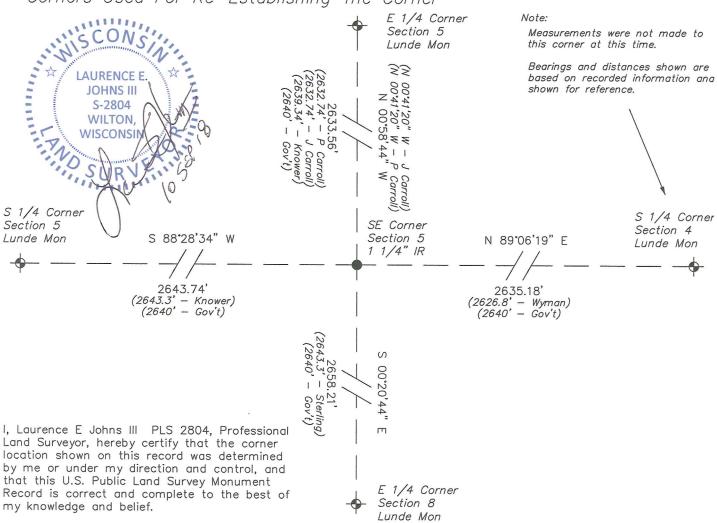
Map Showing Distance And Direction To Other Public Land Survey Corners Used For Re-Establishing The Corner

Distances in all 4 directions fit well with the older surveys by several different surveyors from the late 1800's.
