U. S. PUBLIC LAND SURVEY MONUMENT RECORD

**SECTION 11, T13N, R1W, TOWN OF UNION
VERNON COUNTY, WISCONSIN**

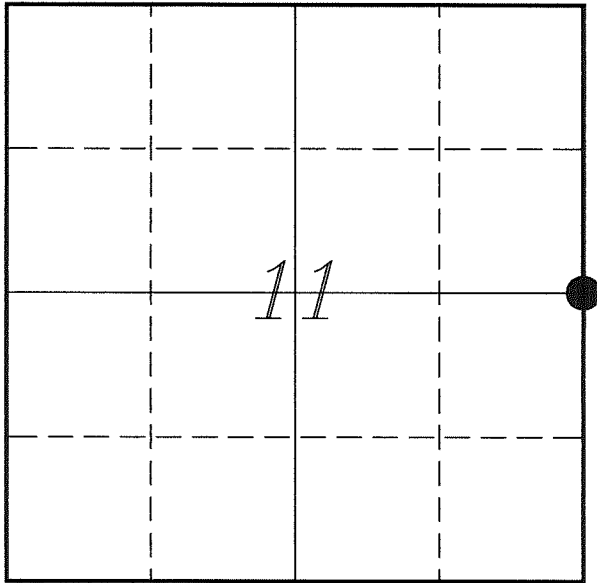
LOCATION OF LANDMARK

VERNON COUNTY COORDINATE SYSTEM	
Northing	171903.382
Easting	817655.556
Datum	NAD 1983 (2011)
Elevation	
Datum	
TYPE OF LANDMARK:	
Existing 1 1/4" Iron Rod	
BEARINGS ARE REFERENCED TO:	
Vernon County Coordinates (Survey Grade)

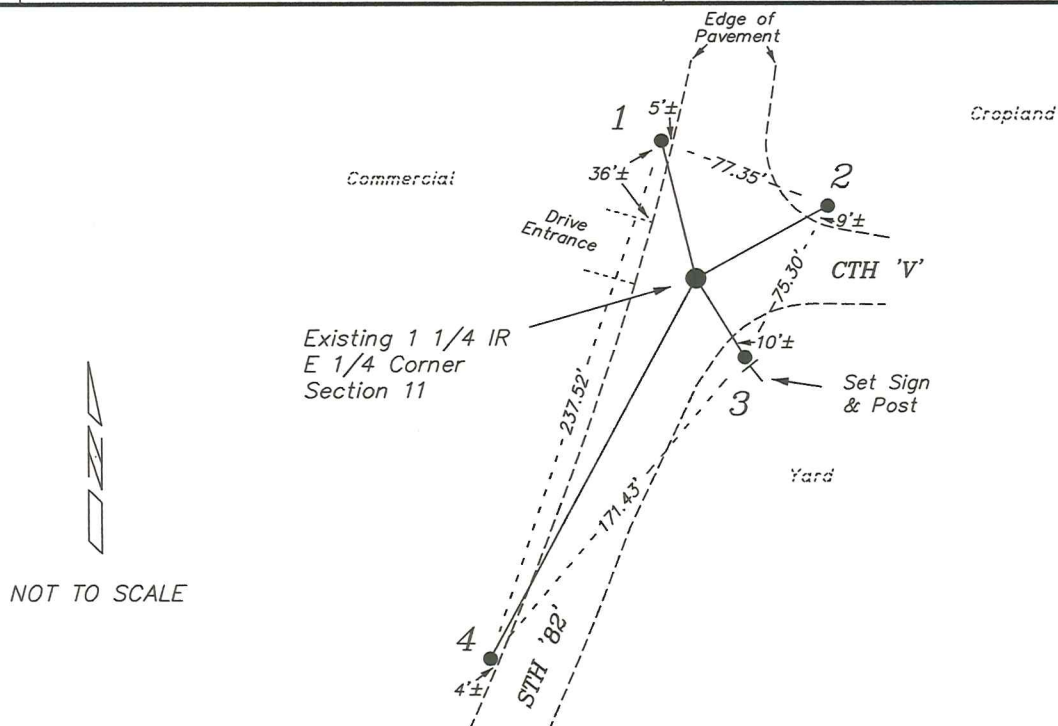
PLAN VIEW DRAWING OF REFERENCE TIES

NO	DESCRIPTION	BEARING	DISTANCE
1	Set 3/4" x 18" Iron Rod 1' South of Co Rd V Junction Sign	N 13°47'31" W	61.85'
2	Set 3/4" x 18" Iron Rod 1' West of Stop Sign	N 61°05'43" E	65.29'
3	Set 3/4" x 18" Iron Rod 1' North of Co Rd V Junction Sign	S 31°19'51" E	40.38'
4	Set 3/4" x 18" Iron Rod 1' West of Hwy 82 Sign	S 28°31'43" W	188.11'
