U. S. PUBLIC LAND SURVEY MONUMENT RECORD

**SECTION 15, T13N, R1W, TOWN OF UNION
VERNON COUNTY, WISCONSIN**

*U. S. PUBLIC LAND SURVEY MONUMENT RECORD
'Addendum for Corner Photographs'*

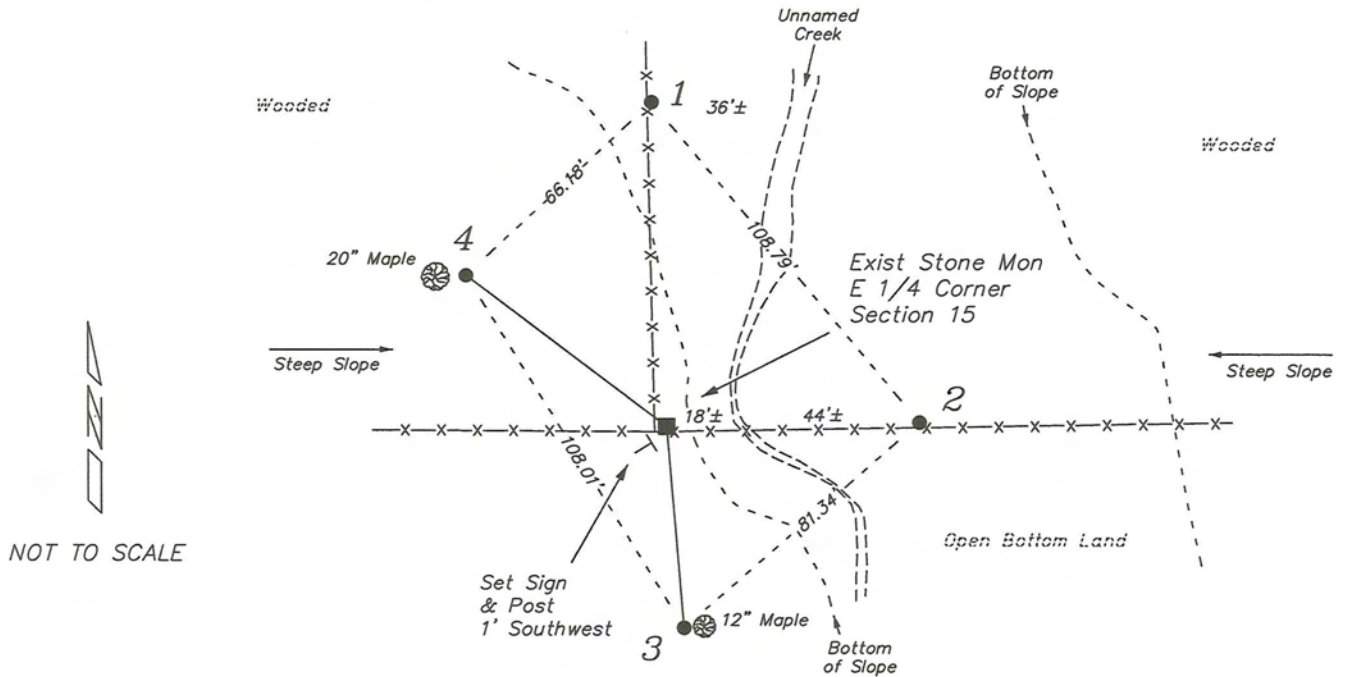
PLAN VIEW DRAWING OF REFERENCE TIES

NO	DESCRIPTION	BEARING	DISTANCE
1	Set 3/4" x 18" Iron Rod In Fence Line	N 02°35'02" W	84.83'
2	Set 3/4" x 18" Iron Rod In Fence Line	N 89°04'07" E	65.71'
3	Set 3/4" x 18" Iron Rod 1' West of a 12" Maple	S 04°51'53" E	52.66'
4	Set 3/4" x 18" Iron Rod 3' East of a 20" Maple	N 52°50'36" W	65.42'

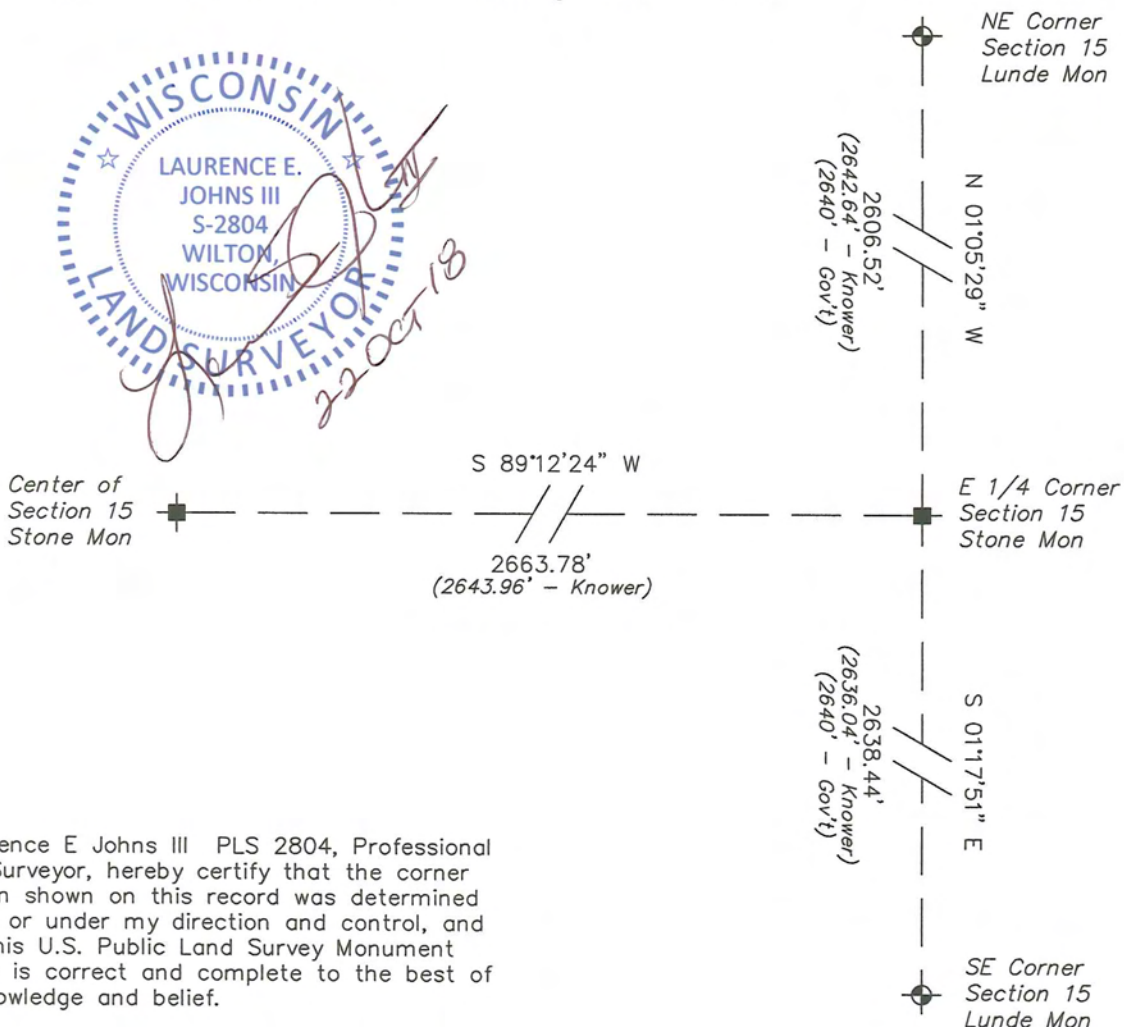
Distances as compared to Knower's survey are relative considering the terrain of the area. To the South it is about 2 feet difference. To the West is about 20 feet and to the North is 36 feet. To the North maybe an error of a half-chain and is in very rough terrain.

Map Showing Distance And Direction To Other Public Land Survey Corners Used For Re-Establishing The Corner

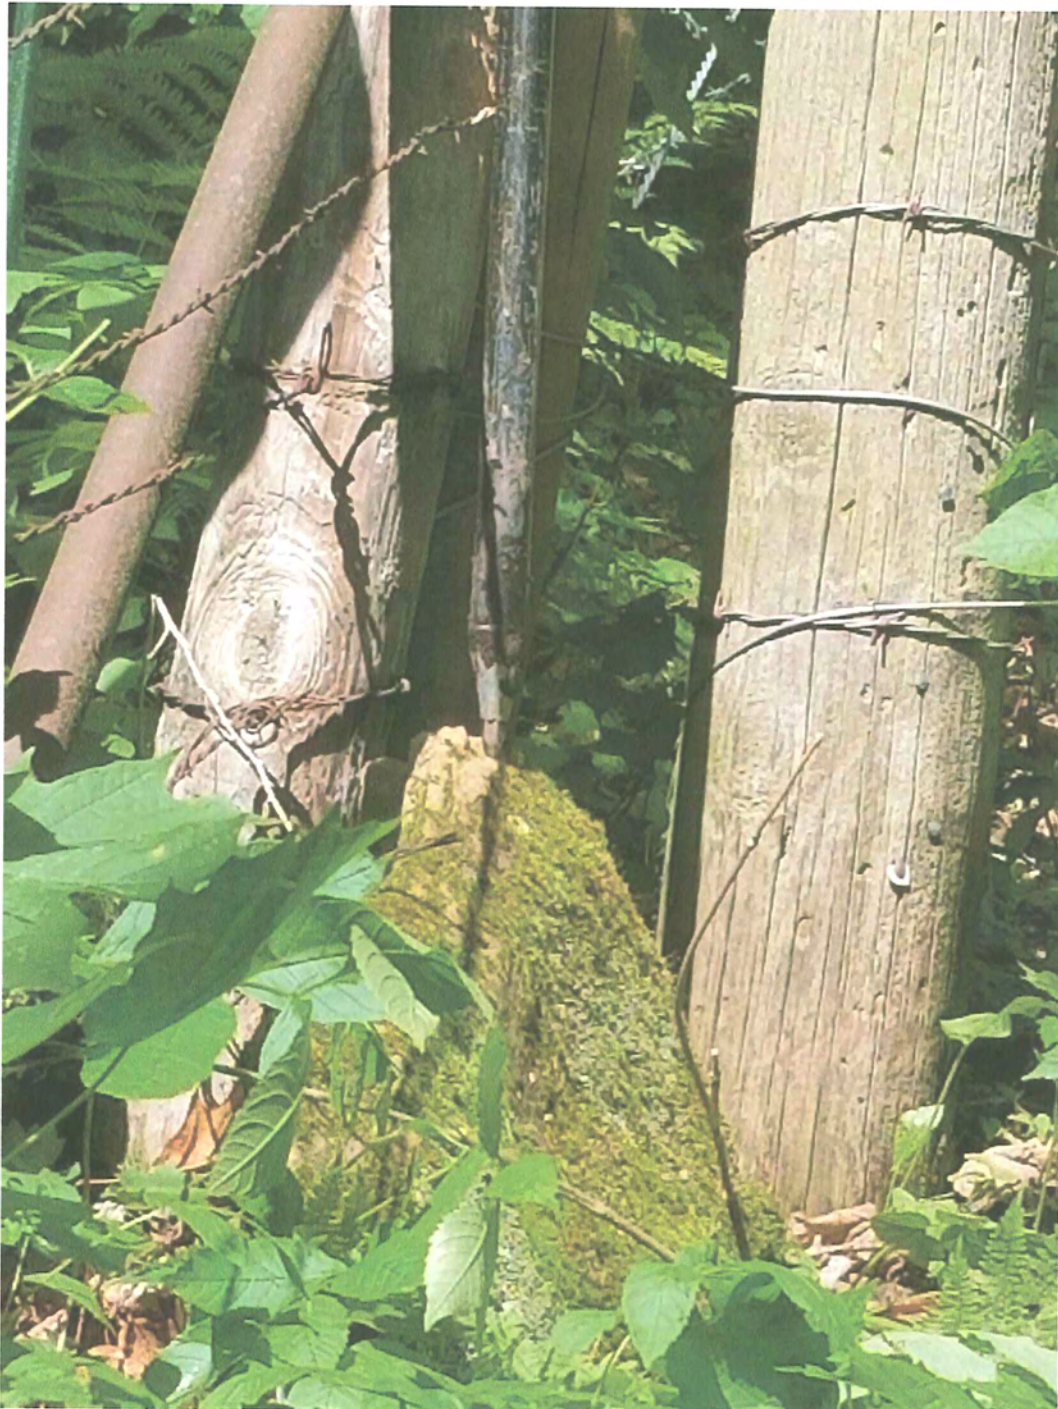
I found a stone of obvious non natural position at the 3-way fence corner.

The positioning of this stone along with the positioning of an old fence corner location only 1 foot away from the stone, I believe that this stone was set by Knower or by the land owner based on Knower's survey.

Taken from the East – Stone at Fence Corner

Due to its size and stable position I did not replace the stone with a Lunde Monument.
